HOME INSPECTION SUMMARY

*John Smith
100 Sample Street, Somewhere, NH
July 9, 2010*

HOME **S**MART
INSPECTIONS

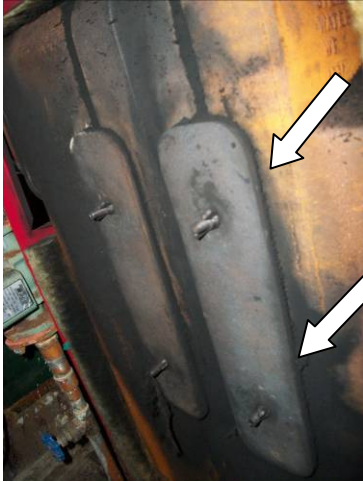
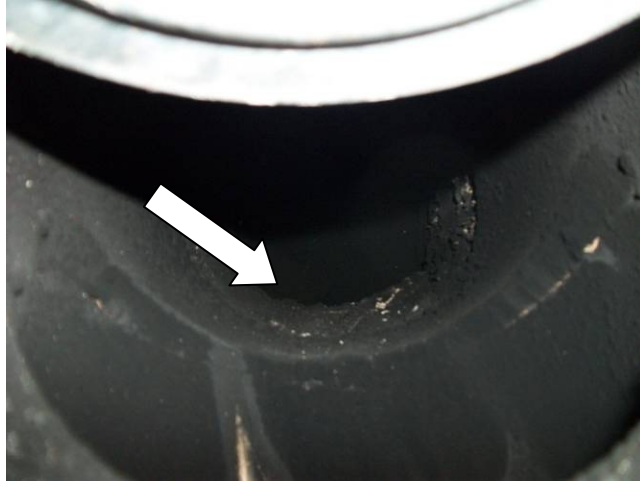
1. Service boiler for tune, clean and complete evaluation– boiler was recently cleaned but cleanout panels were loose/leaking soot and exhaust stack to chimney was not cleaned- visible through draft damper

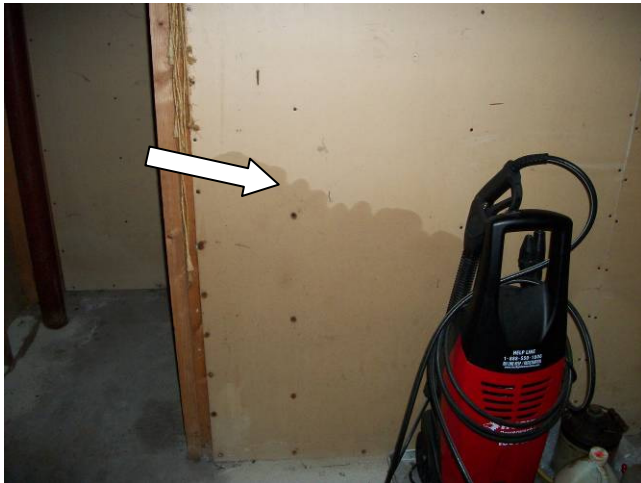
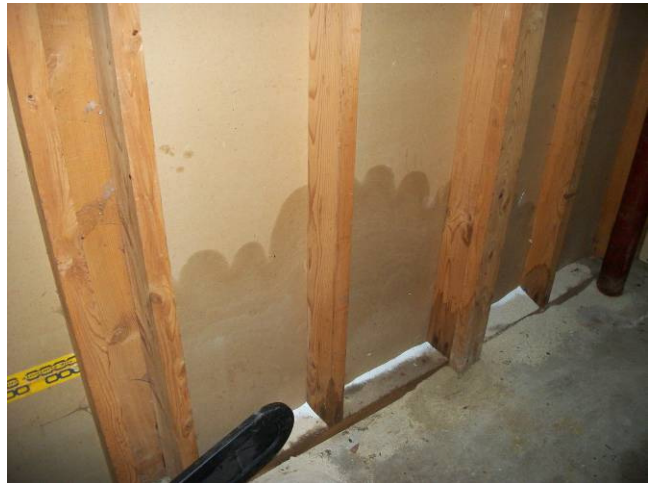
2. Basement and garage has strong odor of oil due to oil leak at boiler in rear basement- oil traveled down rear basement hall and wicked into drywall, framing and carpet- visible in rear finished closet drywall and carpet, hall drywall by shelving and garage closet drywall under stairwell- damaged carpet, drywall and porous materials will need removal to eliminate odor

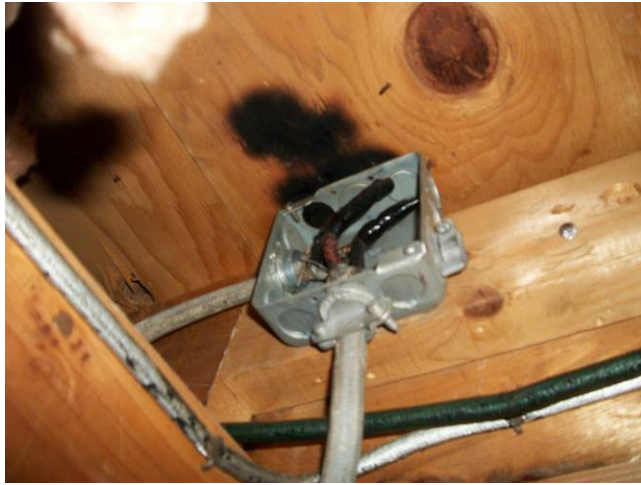
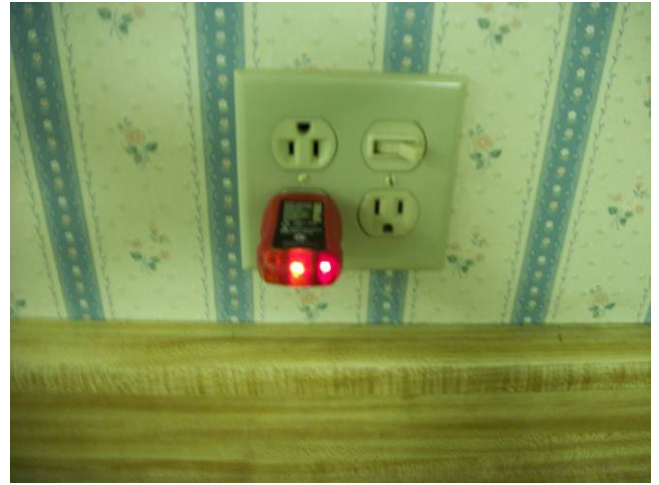
- Garage closet ceiling has electrical junction box with scorch marks above– 220v wires improperly spliced in box, kitchen electrical outlet missing cover plate under sink, kitchen electrical GFCI outlet will not trip to left of stove- replace outlet, basement kitchen counter electrical outlet wired reversed polarity to left of sink, first floor bathroom electrical GFCI outlet wired reversed polarity, living room and dining room electrical outlets have no power- recommend having licensed electrician evaluate/troubleshoot/repair electrical defects

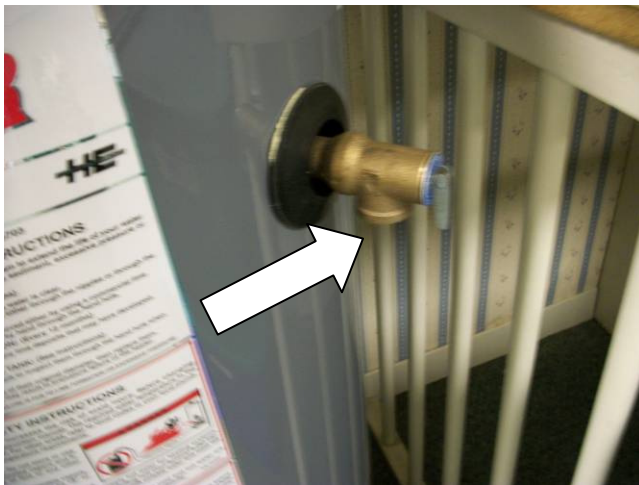
- Basement indirect hot water tank temperature/pressure relief valve is missing an extension- a safety hazard

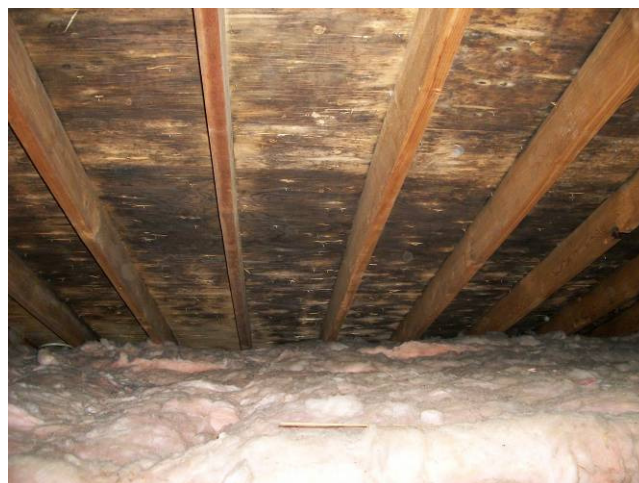
- Attic plywood has extensive moisture staining due to un-insulated whole house fan and un-insulated scuttle hole cover– heat loss through these areas causes condensation/mold growth on attic plywood during winter- recommend removing whole house fan and insulating attic scuttle hole cover with rigid foam board and seal/caulk to eliminate heat loss/moisture sources

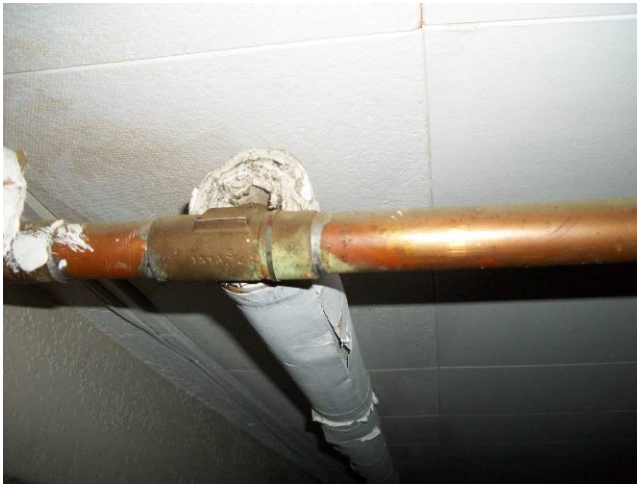
6. Attic ventilation is inadequate contributing to attic moisture problem- roof ridge vent should not be used with gable end vents– recommend removing ridge vent and installing just a ridge cap to allow gable end vents to work properly as cross ventilation
7. Garage ceiling heat pipes wrapped with asbestos insulation– recommend encasing or removing asbestos

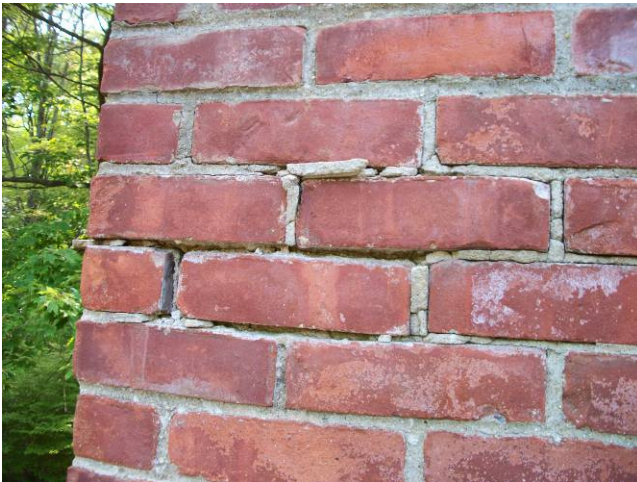
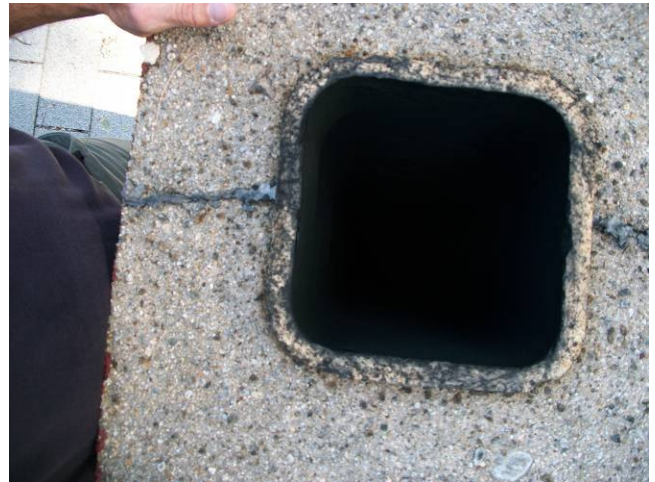
8. Basement utility sink right side drain clogged – cold faucet handle corroded/not functioning
9. Brick chimney mortar is chipping/cracking, block chimney top mortar has cracks and top flue tile has minor spalling – recommend repair/repointing chimneys

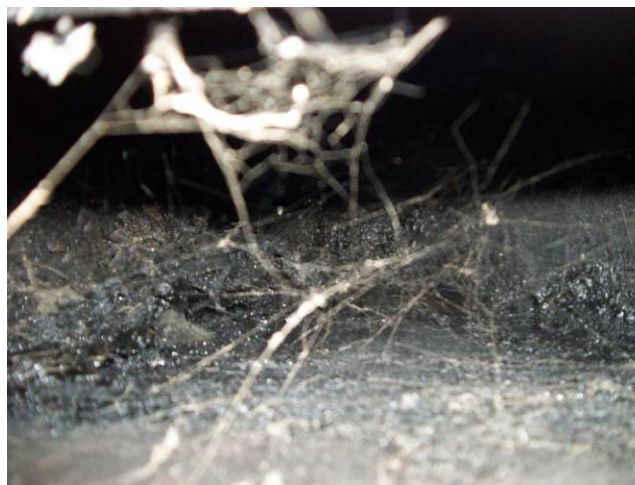
10. Fireplace chimney flue is filled with creosote/debris – recommend having chimney sweep clean and inspect flue liner

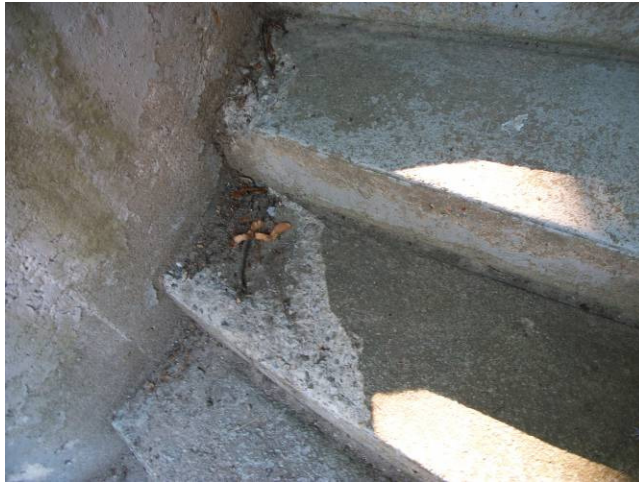
11. Exterior front concrete steps cracked/damaged- recommend repair
